## **USING VISUAL INSPECTION NDT TO CHECK INTEGRITY OF TRIGA MARK I FUEL RODS**

**Donizete A. Alencar<sup>1</sup>, Silvério F. Silva Júnior<sup>1</sup>, Luiz O. I. Sette Câmara<sup>2</sup>,  
Paulo F. Oliveira<sup>2</sup>, Amir Z. Mesquita<sup>2</sup>, Antonio T. Silva<sup>3</sup> and José A. Perrota<sup>3</sup>**

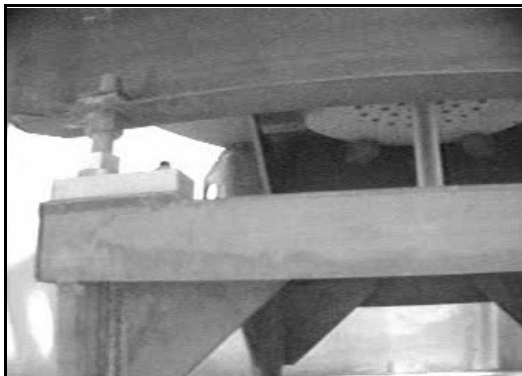
Within the limits of the method, the first inspection showed that all structural components, the core and the tank of the reactor were in good conditions. Concerning to the fuels, seven indications were pointed, as presented in Table 1. In the second inspection, the structural components, the core, the tank of the reactor and the fuels listed in Table 1 were re-examined. After 6 years of operation, none severe changing was verified. Six representative images, taken from the recorded video files, are presented in Fig. 6 to Fig. 11.

**Figure 6. View of the reactor structure.**

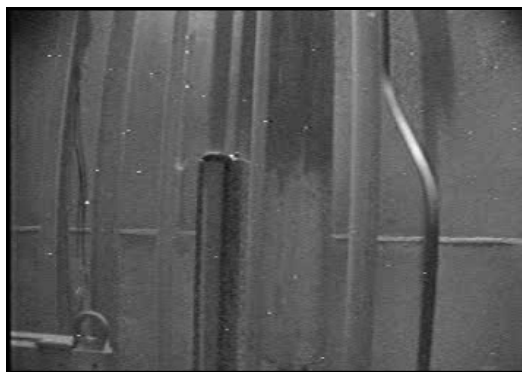
<b>Fuel Identification</b>	<b>Position in the core</b>	<b>Indicação</b>
1179	E-18	Deformation (kneading) in the lower termination pin
1314	B-1	Deformation (bending) in lower termination pin
1199	D-11	Corrosion pit
1220	D-13	Oxide film color difference in the active/inactive zone
1147	E-23	Oxide film color difference in the active/inactive zone
1188	B-2	Corrosion pits
1205	E-6	Deformation (kneading) in the lower termination pin

**Figure 8. Fuel 1220 color difference.**

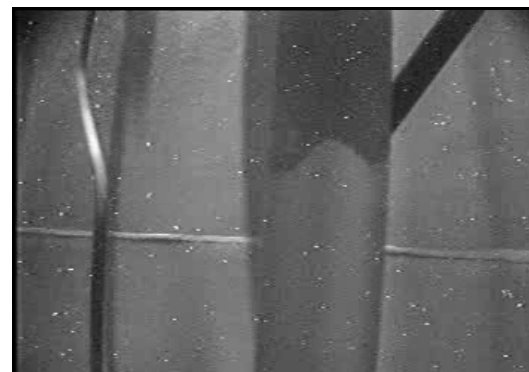
**Figure 9. Fuel 1147 color difference.**

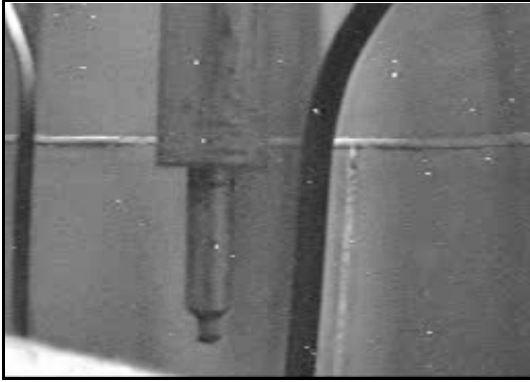
**Figure 10. Fuel 1179 kneaded pin.**

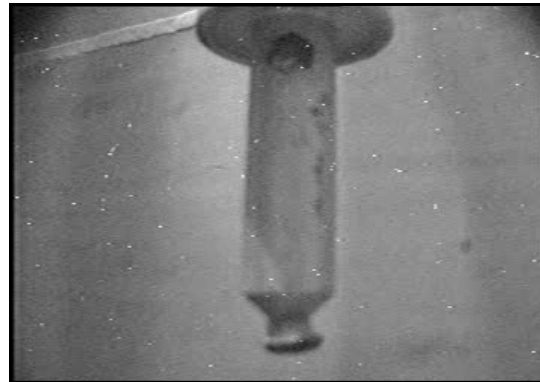
**Figure 11. Fuel 1205 kneaded pin.**
